# RISING ABOVE THE RISK

## ELEVATION AND RECONSTRUCTION MITIGATION ASSESSMENT

### HURRICANE IDA IN JEFFERSON PARISH

June 2022

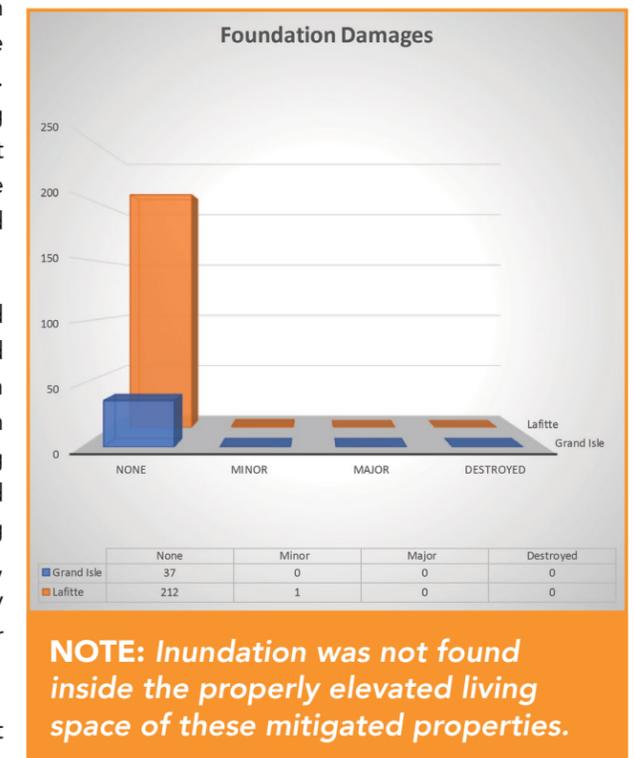
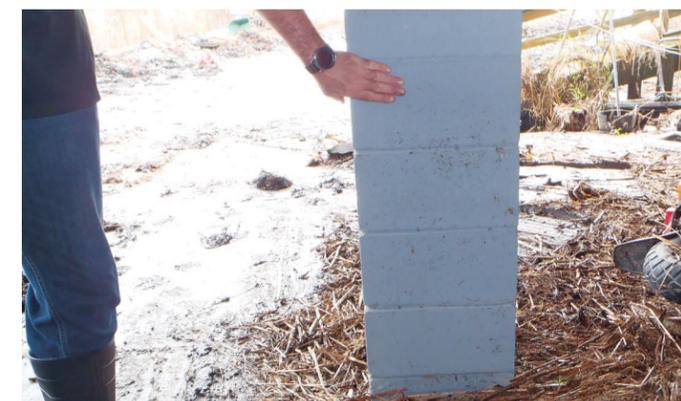
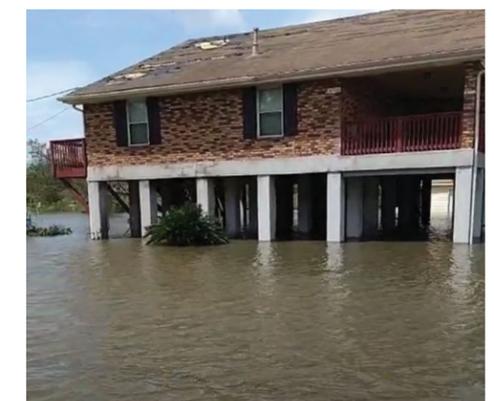
As such, foundation damage was not observed on-site during the team’s field assessments and only one structure was noted to have had an impact to the foundation per conversation with the homeowner. It was made evident during evaluation that the elevated structures mitigated through Jefferson Parish and evaluated during this assessment were successful in this element, as none of the 288 structures assessed had any visible damage to the foundation system and/or foundation components.

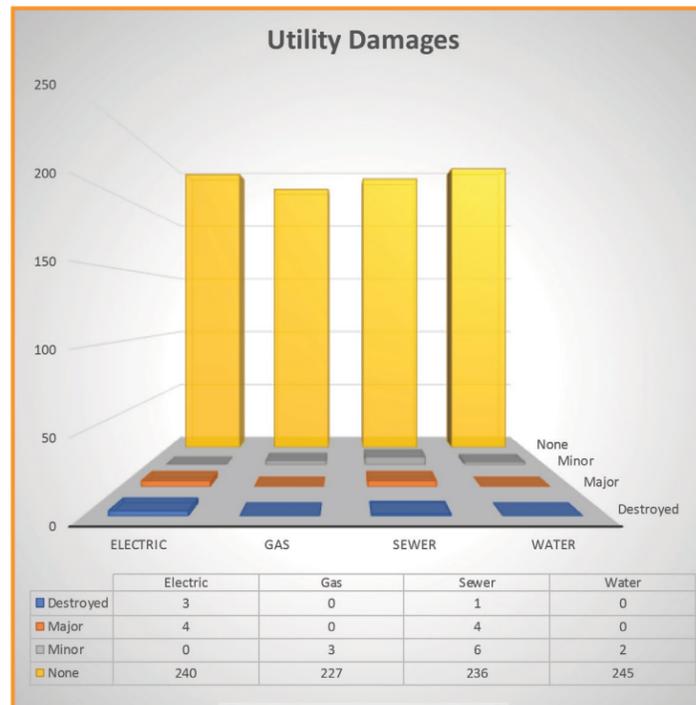
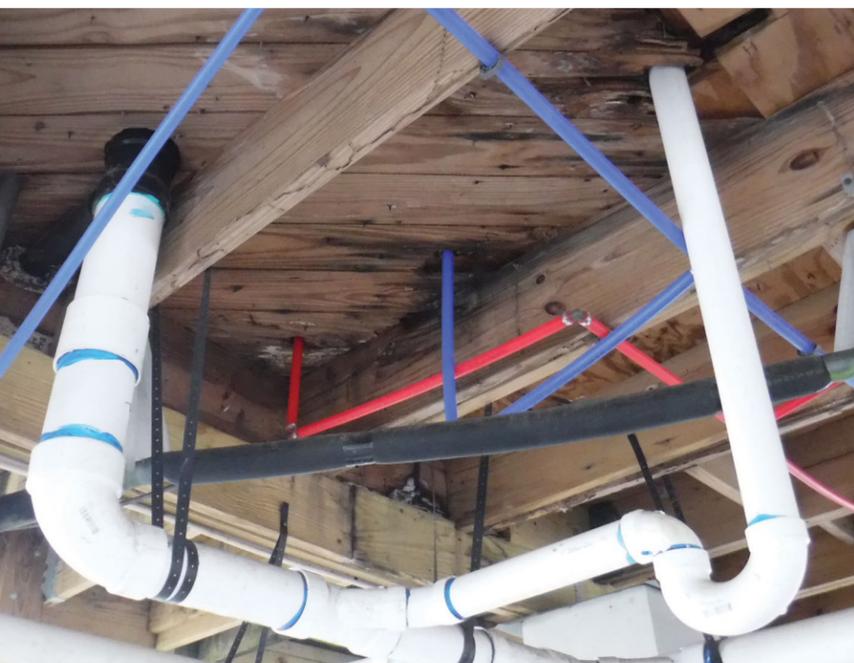
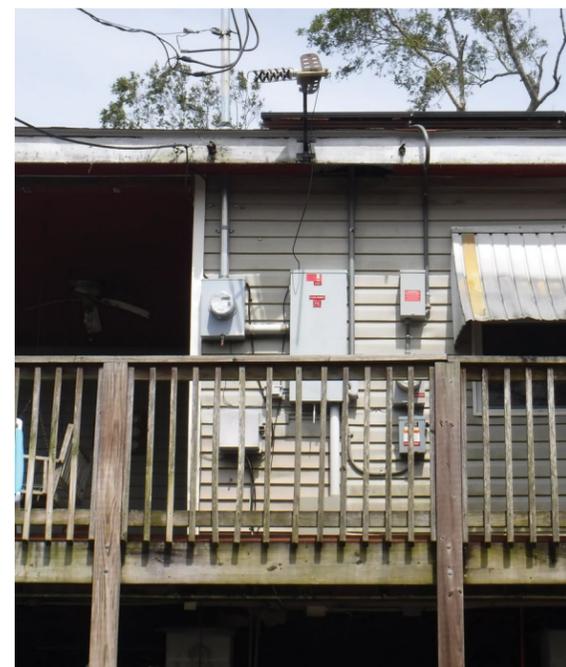
Taking into account this added vulnerability of these utility components, the impacts to the structures' mechanical elements still resulted in a very low impact to utilities and utility connections at the assessed sites. The majority of damages observed were a result of storm debris.

- » When feasible gas meters should be relocated to a less vulnerable area
- » When feasible water and sewer lines should be installed in-line with or next to piles, piers, or horizontal cross beams for added protection
- » All electric meters should be raised at/above the base flood elevation

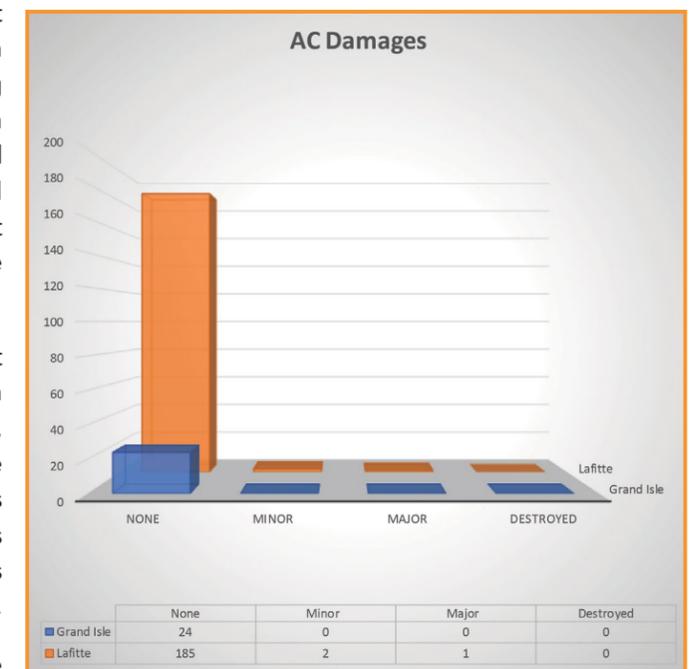
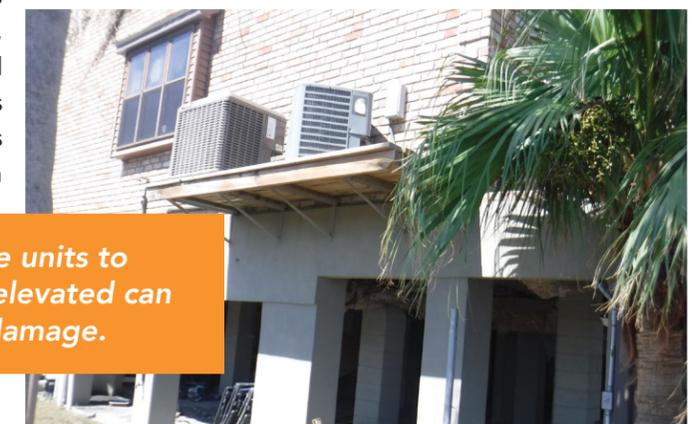
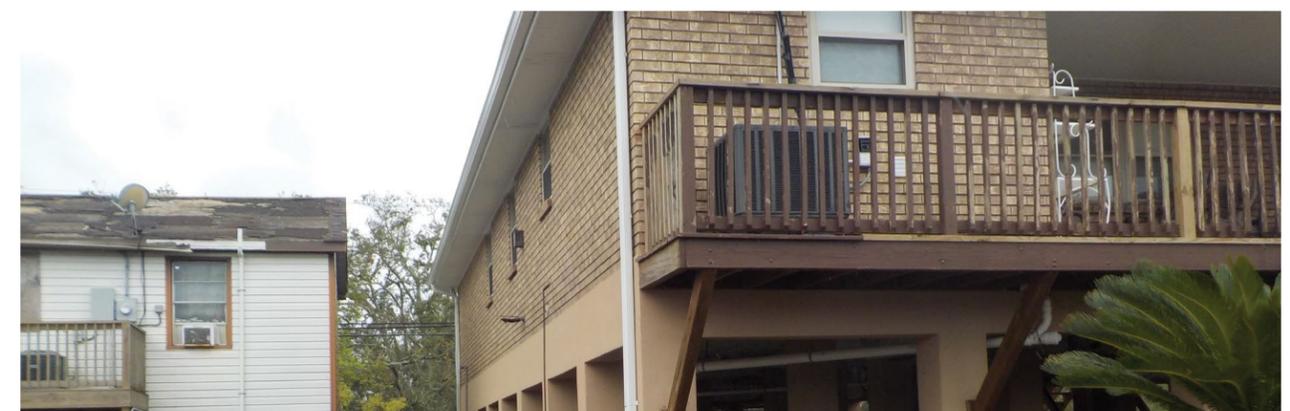
You will notice in the photos below that the air conditioning units are raised on platforms, either as a stand-alone structure, a platform tied into the foundation of the structure itself, or on a deck that also serves as a point of ingress/egress. All methods are feasible, and the majority of the units assessed were unaffected by Hurricane Ida.

In the very few cases that impacts were noted, it was observed that the units had shifted on their elevated platforms, and it was determined that this could potentially be prevented in future events by securing the units once elevated. This is already being implemented in Jefferson Parish mitigation projects as a result of this mitigation assessment.

**TIP:** Securing the units to platforms once elevated can prevent future damage.

- » All air conditioning units should be secured/anchored to their platform
- » Air conditioning unit platforms should have added supports when anchored to the side of a structure

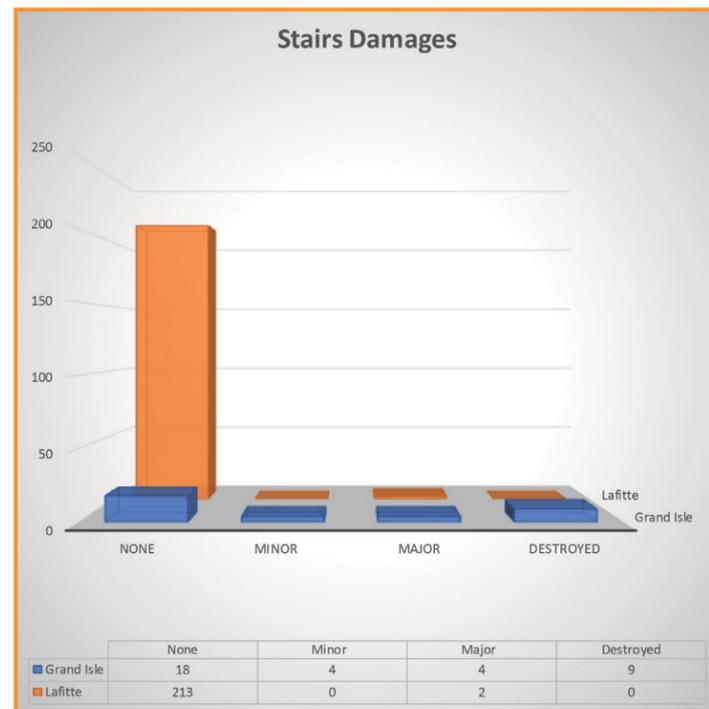
The majority of damage to stairs was from water and wind-driven debris. In the areas of Barataria, Crown Point, and Lafitte the storm surge brought in swift-moving water with mud and marsh grass that impacted the stairs. In Grant Isle the storm surge brought in a rapid influx of water and sand that caused items stored under homes to become projectiles that damaged stairs.

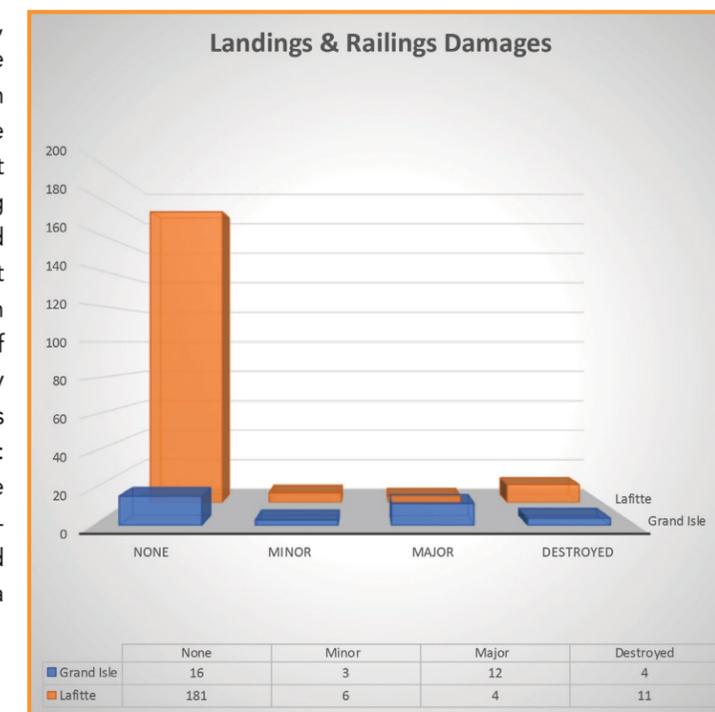
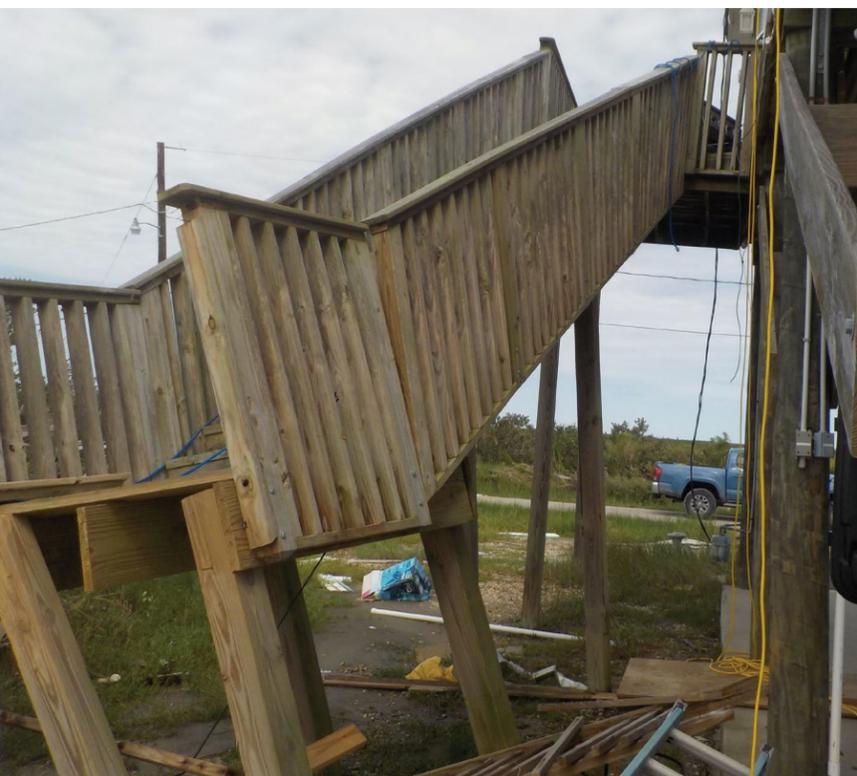
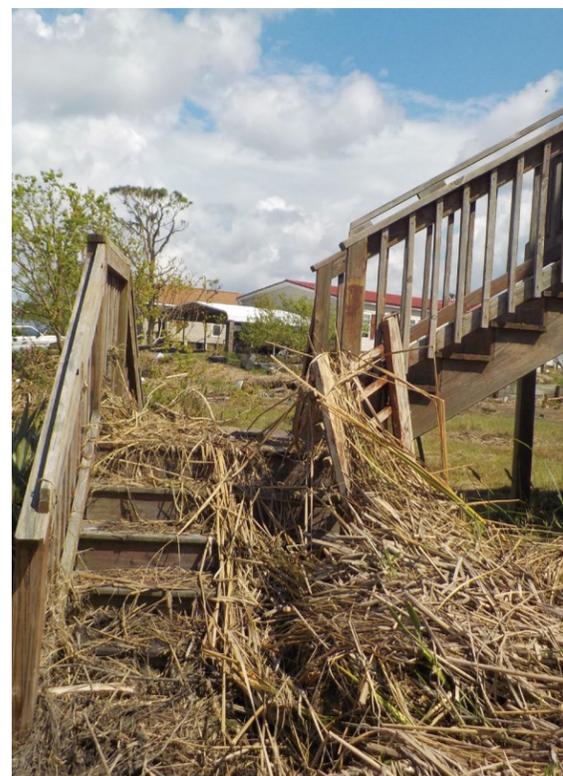
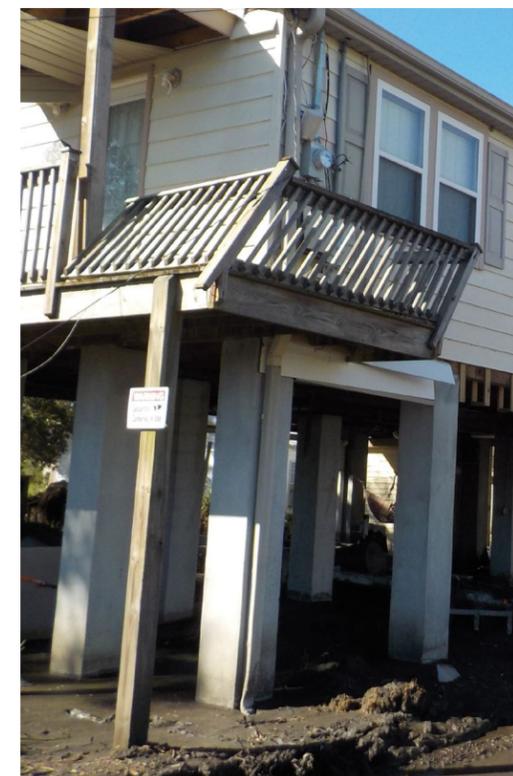
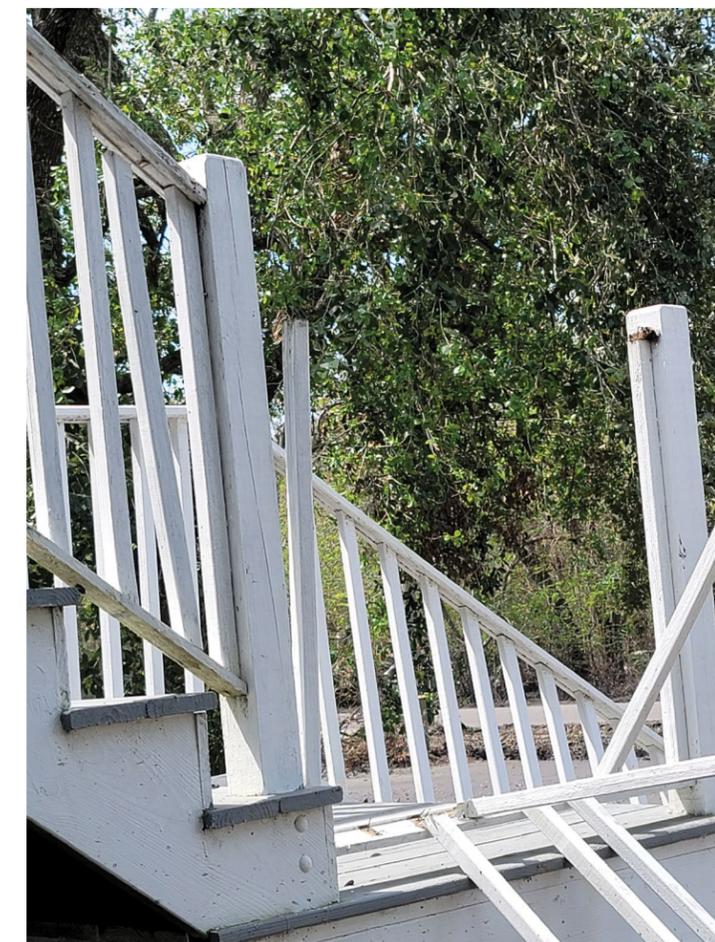
In relation to the other components evaluated, landing & railings statistically show more damage. The Mitigation Assessment Team observed a number of railings that came detached from stairs and landings without any apparent impact from debris. After taking a more in-depth look at what could have led to these failures, and more importantly, what could possibly be done to prevent them in the future, it was noted that a large number of impacted railings appeared to be extremely weather-worn. There are a number of factors that could lead to this condition, including: failure to properly seal/treat wood at the time of installation; deferred maintenance to re-apply sealants periodically; and accelerated deterioration of wood from installation in a marine environment.

**NOTE:** A number of impacted railings appeared to be attributed to deferred maintenance.

- » When feasible screws should be used instead of nails
- » Pre-existing second story railings should be reinforced at the time of mitigation

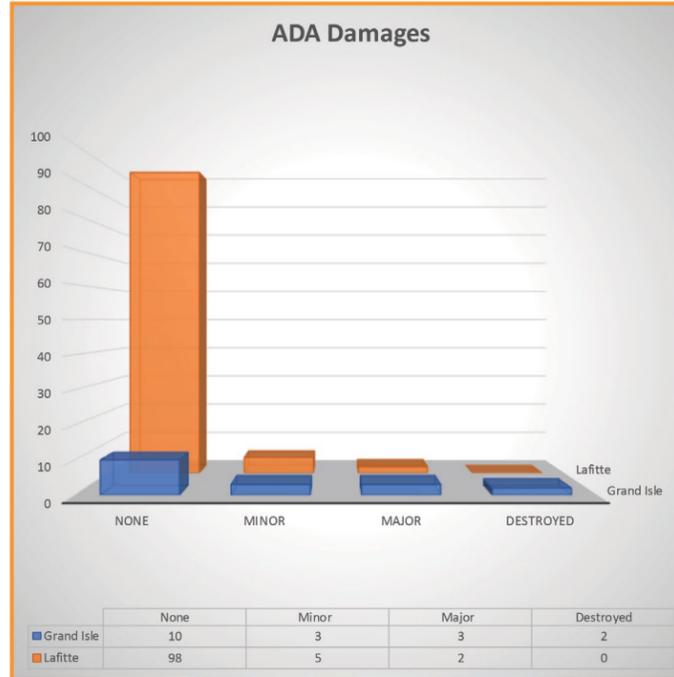
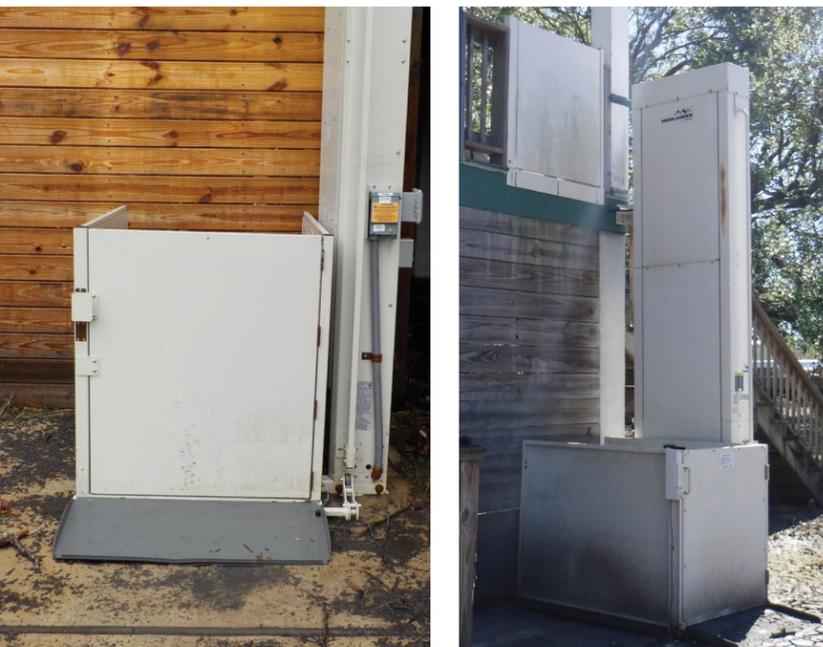
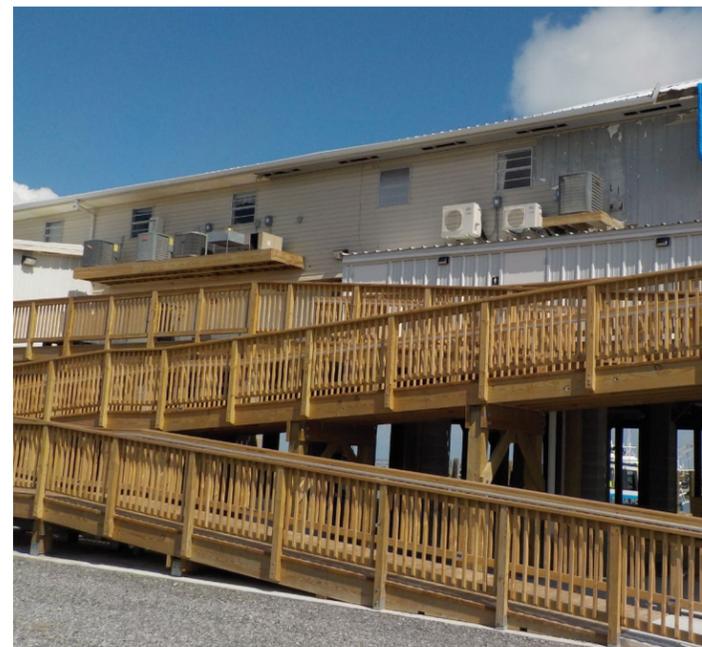
The Mitigation Assessment Team did observe a number of damaged ADA mechanical lifts during field observations. Most of those component failures were due to the bucket portion of the lift being left at grade causing them to be submerged in water, as well as being impacted by the fast-moving storm surge influx. A few units were impacted by wind, but the damage was minor and did not cause the lift to be out of service.

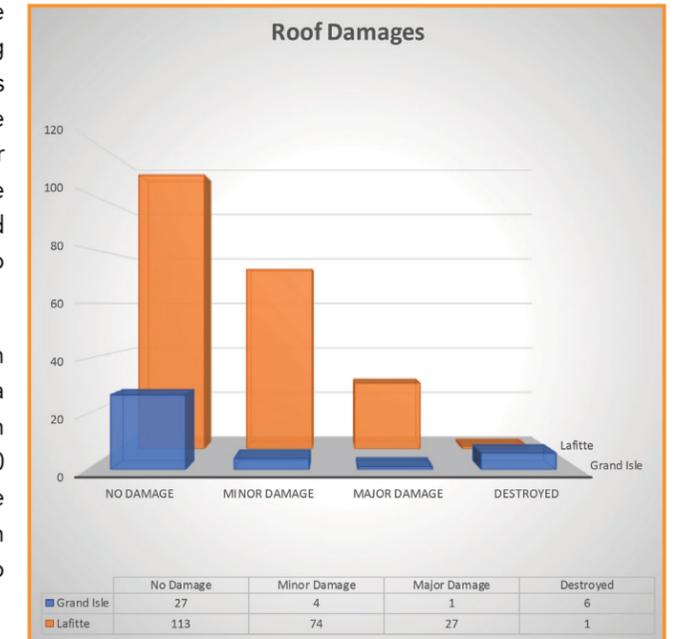
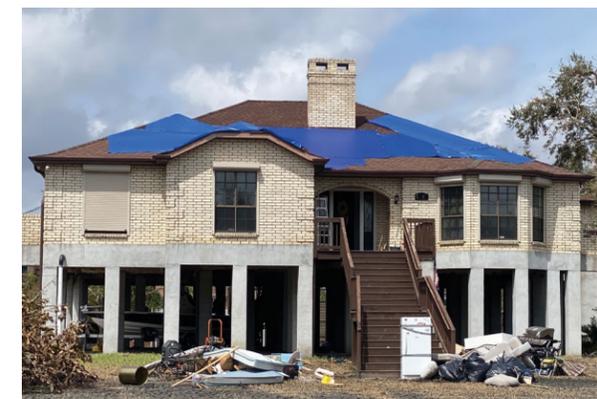
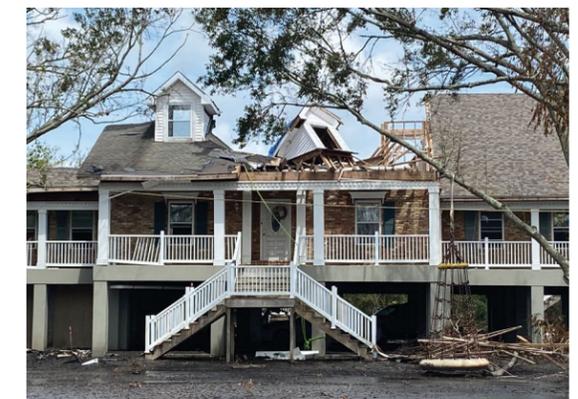
The largest volume of damage observed in the mitigation assessment was to roofs, including awnings & overhangs, and components related to the roof like soffit & fascia. This type of destruction can be expected with a major hurricane, and it is worth noting that these structures were all mitigated from the flood hazard, not wind, so avoided wind damage to these components was not anticipated.

The Town of Grand Isle is classified as a Zone VE, which is considered a high risk coastal area prone to additional hazards associated with storm waves. In order to protect these structures from the threat of flood hazards, they are elevated 8-10 feet on average in order to be at/above BFE. This drastic change in vertical positioning unfortunately makes these mitigated structures more vulnerable to the threat of wind and less likely to survive a major hurricane without sustaining wind damage. Evidence of this was certainly seen during this assessment. Six of the structures assessed in the Town of Grand Isle suffered complete destruction of their roof and five others sustained roof damage.

In the areas of Lafitte, Barataria, and Crown Point, mitigated structures have also been raised as high as 12 feet and are more vulnerable to wind damage post-elevation/reconstruction. In the Town of Lafitte and lower Lafitte, only one home was documented as the roof having been destroyed, but twenty-seven others suffered major damage to their roof covering.

- » Wind mitigation measures must be included at the time of elevation if structure is being raised more than eight feet above grade
