# RISING ABOVE THE RISK

## ELEVATION AND RECONSTRUCTION MITIGATION ASSESSMENT

### HURRICANE IDA IN JEFFERSON PARISH

June 2022

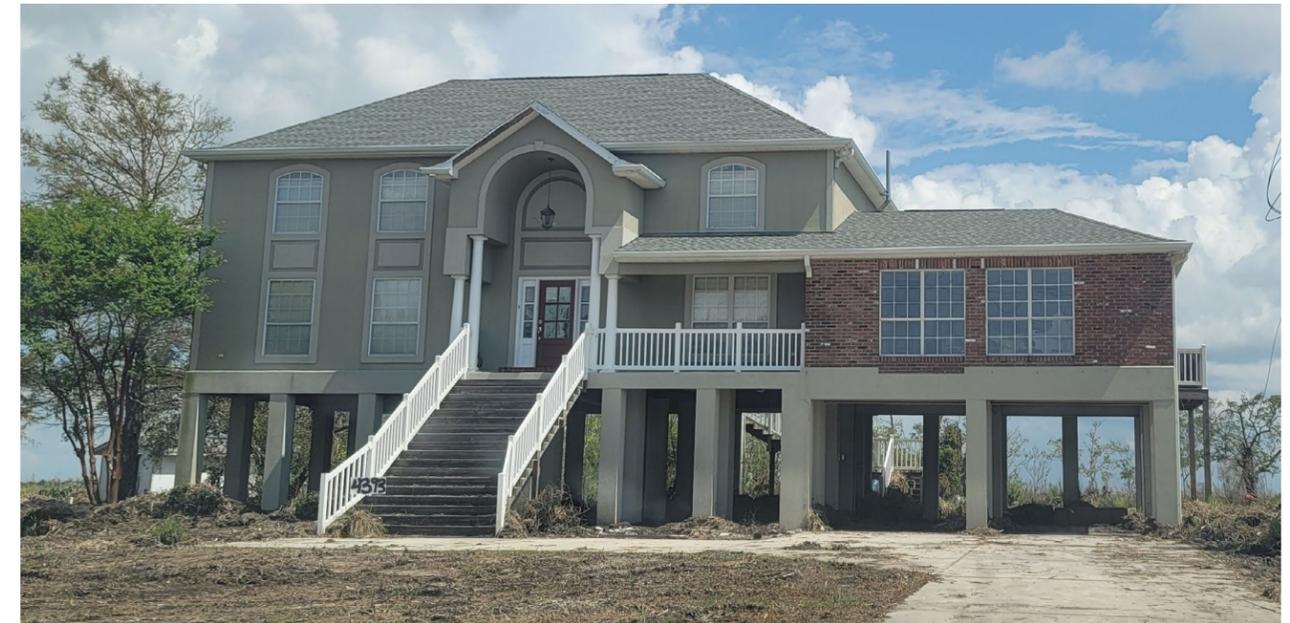
### 3.1.6 | ROOFS

In the areas of Lafitte, Barataria, and Crown Point, mitigated structures have also been raised as high as 12 feet and are more vulnerable to wind damage post-elevation/reconstruction. In the Town of Lafitte and lower Lafitte, only one home was documented as the roof having been destroyed, but twenty-seven others suffered major damage to their roof covering.

- » Wind mitigation measures must be included at the time of elevation if structure is being raised more than eight feet above grade
